## Smoke and Dye-Water Observation Summary

### Western Run Pilot Project - Baltimore Maryland

## INSPECTION REPORT

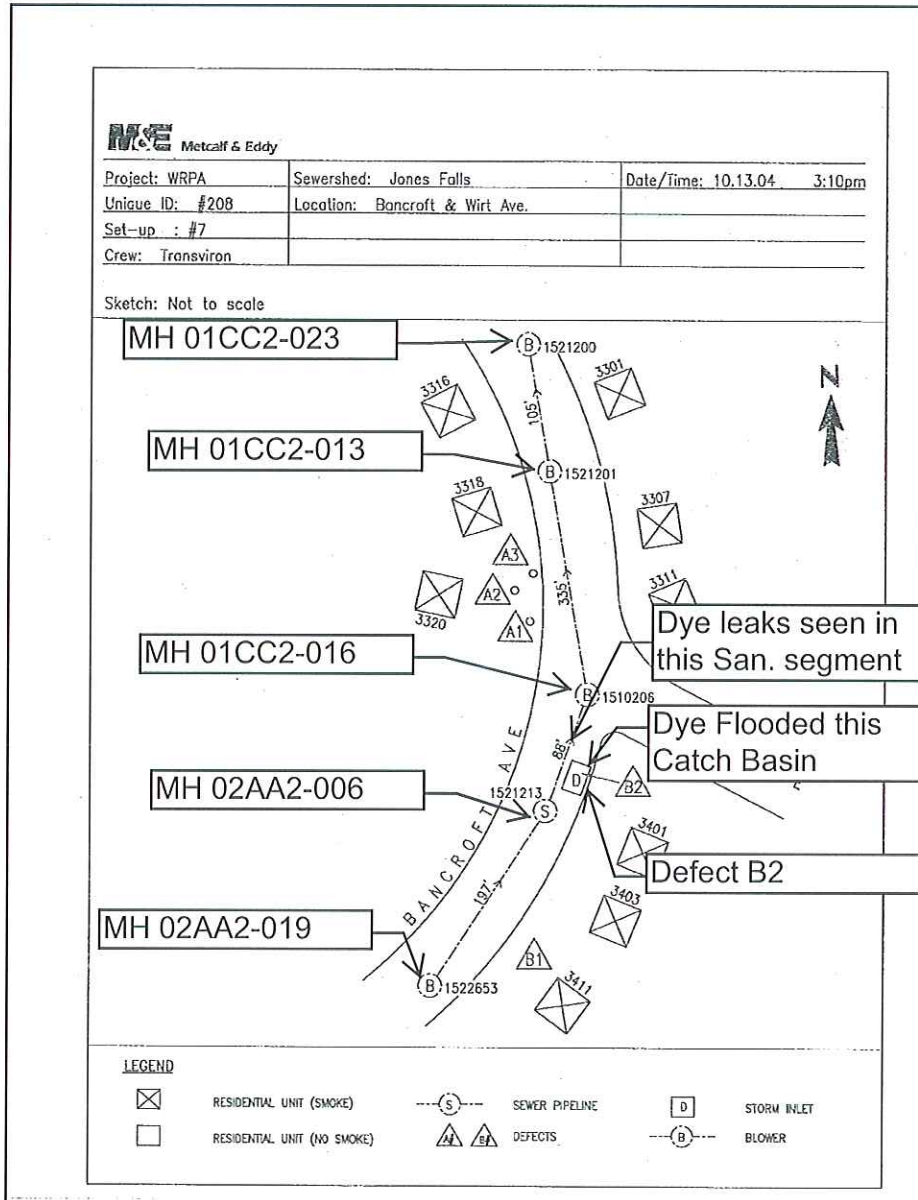
Sketch No: 208

NO DYE LEAKS  
IN THIS SAN.  
LINE

PLUGGED  
STORM

Dye Flooded this  
Catch Basin

Defect B2

A lot of Dye leaks seen  
in this San. segment.

IN THIS  
SAN. LINE.

ALMOST  
EVERY JOINT

DYE  
FLOODED  
C.B.

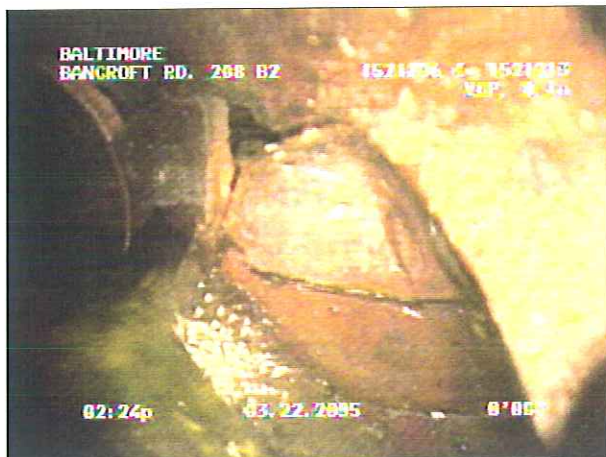
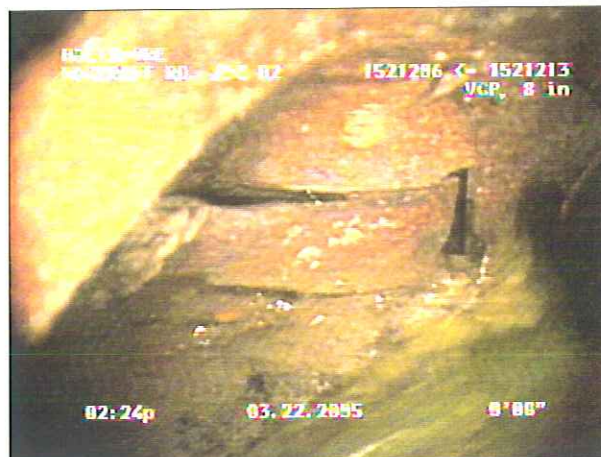
1:225	DIST	OBSERVATION	RATE	VCR #	PH
	0.00	inspection begins at downstream manhole, 1521206	0	01:31:00	
	3.00	pipe Broken at 03 o'clock to 9 o'clock	3	01:31:53	101a, b

IMAGE: 101a, TAPE #: JAM 1, 01:31:53  
3FT, pipe Broken at 03 o'clock to 9 o'clock

IMAGE: 101b, TAPE #: JAM 1, 01:31:53  
3FT, pipe Broken at 03 o'clock to 9 o'clock

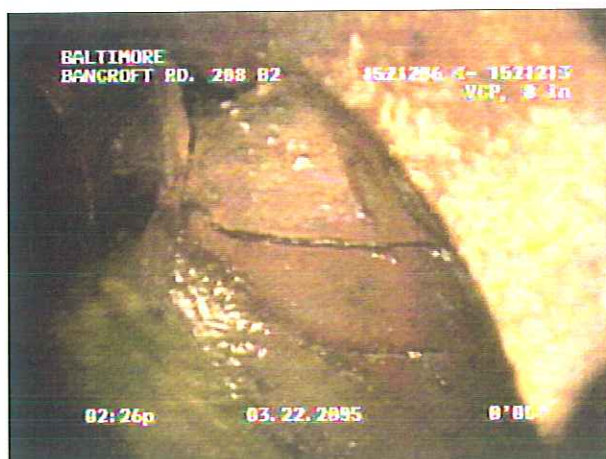
IMAGE: 102a, TAPE #: JAM 1, 01:31:53  
3FT, Infiltration Running from 03 to 09 o'clock

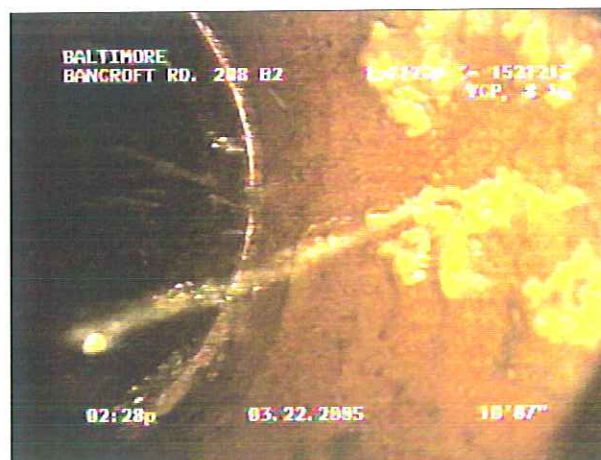
IMAGE: 103a, TAPE #: JAM 1, 01:32:57  
10.56FT, Infiltration Running at joint at 12 o'clock, at crack

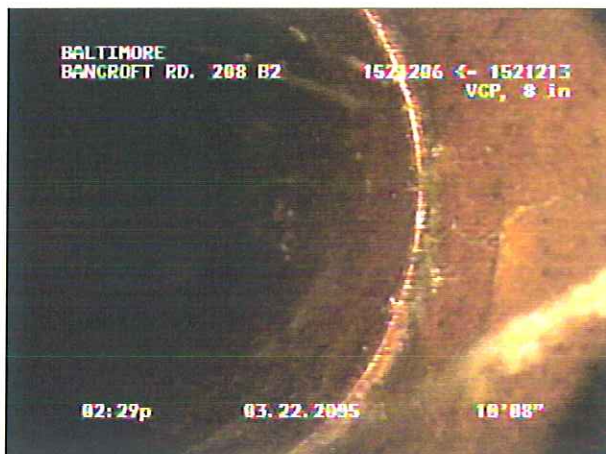
IMAGE: 104a, TAPE #: JAM 1, 01:33:12  
10.66FT, Infiltration Running at joint at 12 o'clock

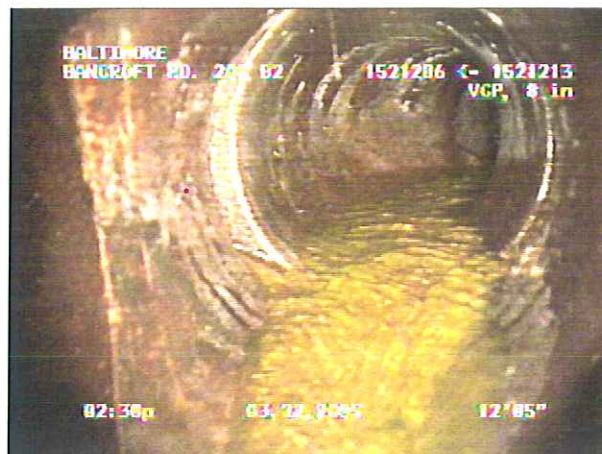
IMAGE: 105a, TAPE #: JAM 1, 01:33:52  
12.38FT, service connection with infiltration running inside at 03 o'clock

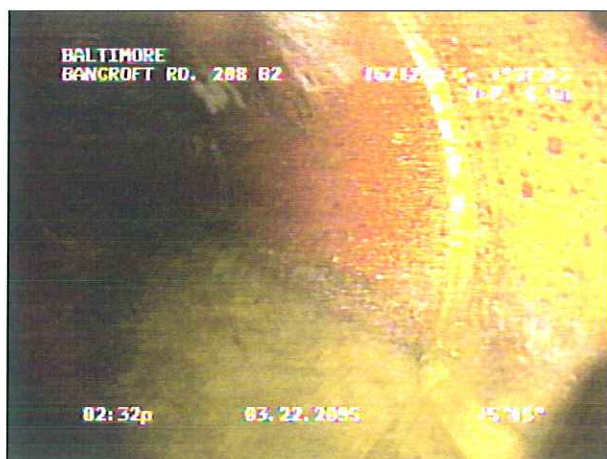
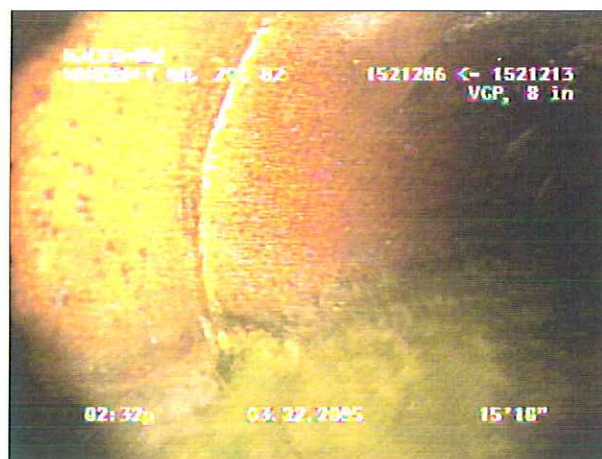
IMAGE: 106a, TAPE #: JAM 1, 01:34:36  
15.8FT, Infiltration Running at joint at 04 o'clock to 8 o'clock

IMAGE: 106b, TAPE #: JAM 1, 01:34:36  
15.8FT, Infiltration Running at joint at 04 o'clock to 8 o'clock

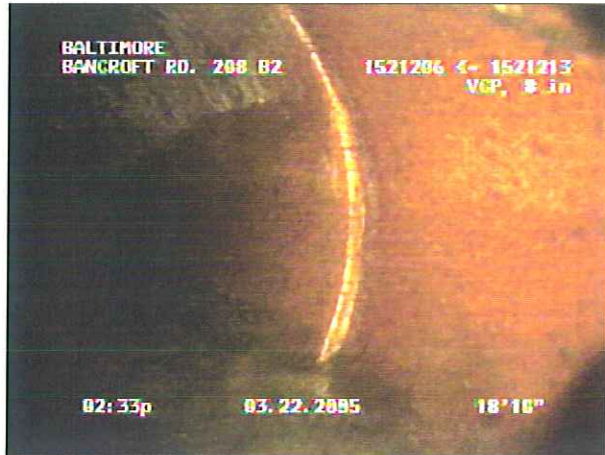
IMAGE: 107a, TAPE #: JAM 1, 01:35:09  
18.81FT, Infiltration Running at joint at 03 o'clock to 8 o'clock

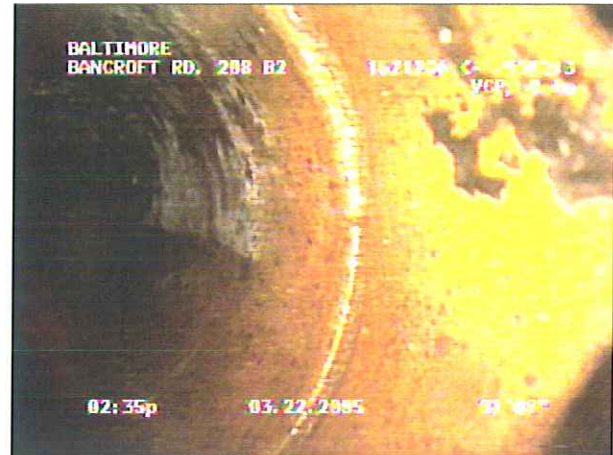
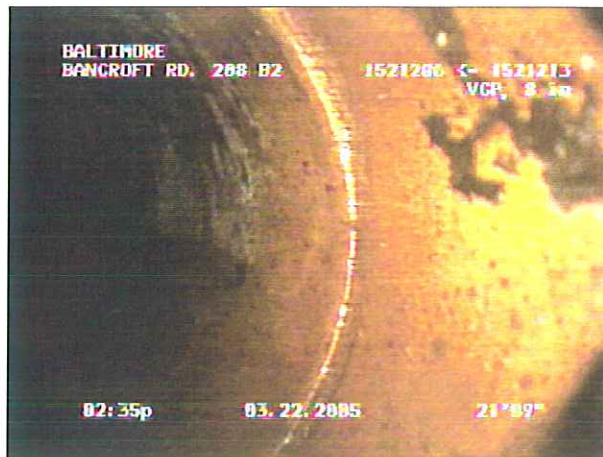
IMAGE: 108a, TAPE #: JAM 1, 01:35:48  
21.73FT, Infiltration Seeping at joint at 02 o'clock to 8 o'clock

IMAGE: 108b, TAPE #: JAM 1, 01:35:48  
21.73FT, Infiltration Seeping at joint at 02 o'clock to 8 o'clock

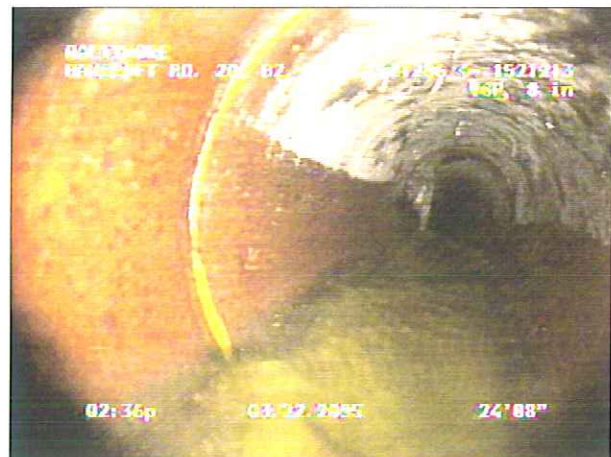
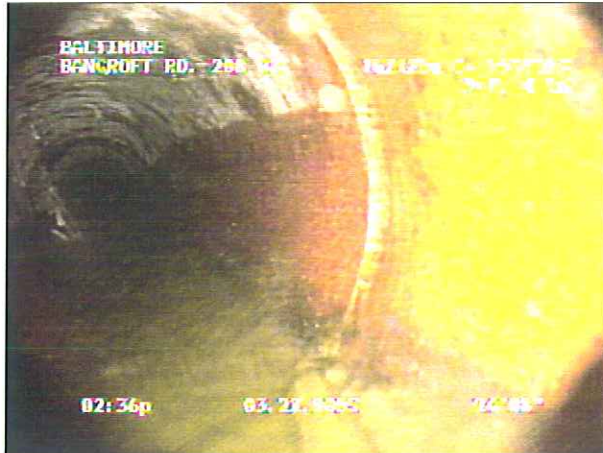
IMAGE: 109a, TAPE #: JAM 1, 01:36:10  
24.65FT, Infiltration Running at joint at 04 o'clock to 9 o'clock

IMAGE: 109b, TAPE #: JAM 1, 01:36:10  
24.65FT, Infiltration Running at joint at 04 o'clock to 9 o'clock

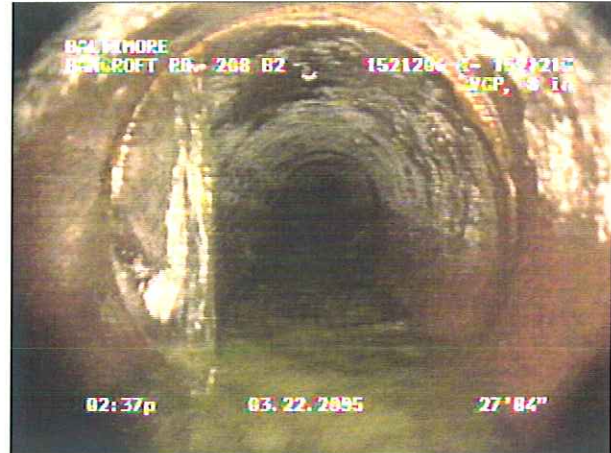
IMAGE: 110a, TAPE #: JAM 1, 01:36:37  
27.37FT, Infiltration Running at joint at 07 o'clock to 11 o'clock

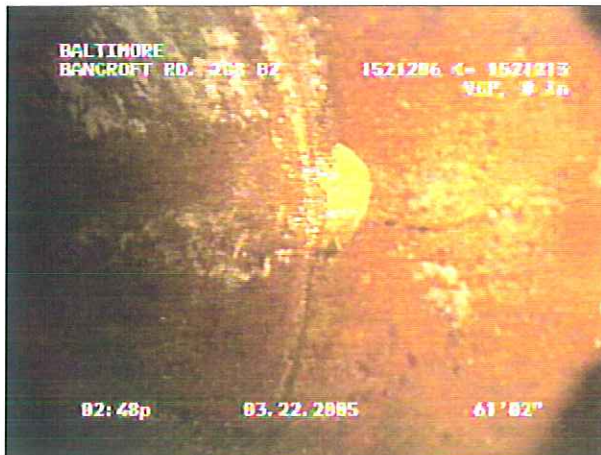
IMAGE: 119a, TAPE #: JAM 1, 01:42:14  
61.17FT, Longitudinal Crack at joint at 03 o'clock and infiltration
